Engineering Field Trip Report

Fine Gold Reservoir

Study Team Field Trip Report (June 12, 2002)

Upper San Joaquin River Storage Investigation Field Trip Logs

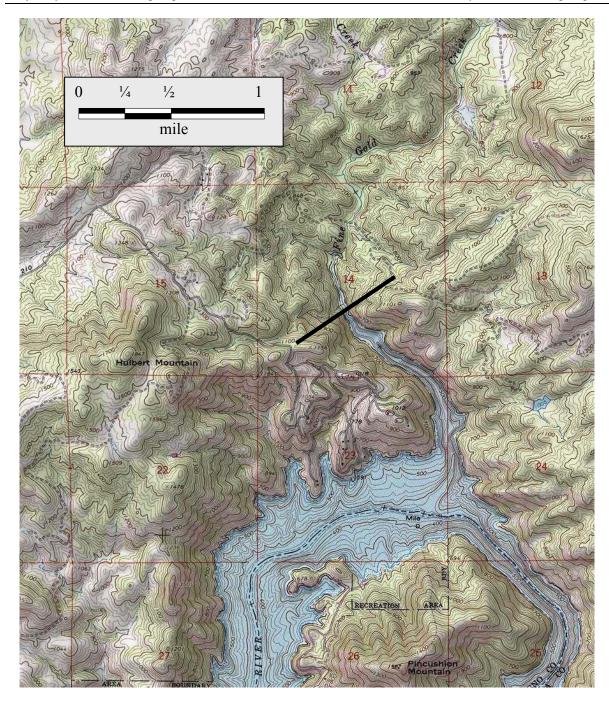
<u>Fine Gold</u> - Upstream view of Fine Gold Creek.
